Property Inspection Report

**6415 Timber Arch Drive
Chaska, MN 55318**

Date of Inspection
February 28th, 2023
2:30 PM

Nifty Home Inspections
6517886735

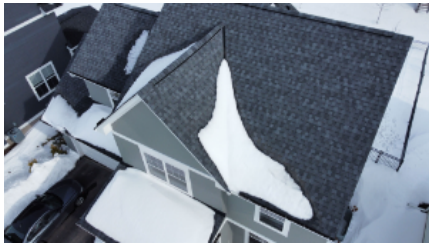
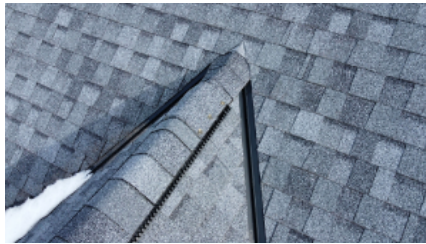
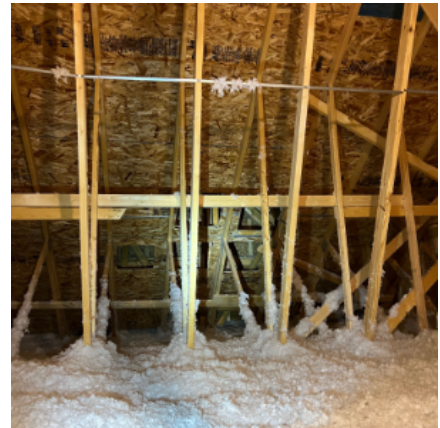
**Roof / Attic
Ventilation**
Section 8.1
Page 10

Ridge Vent is open air exchange, during heaving winds and snow fall, snow accumulates against ridge vent. During warm weather snow melts and flows into interior attic space. This event is causing a moisture pool around the entryway light fixture. Water then drains down the power cord and chain, resulting in water collecting in light fixture. Moisture in contact with electrical current poses concern of personal injury and inoperable lighting fixture. I recommend replacing ridge vent with different style that has a proper barrier to the exterior elements to avoid moisture intrusion.

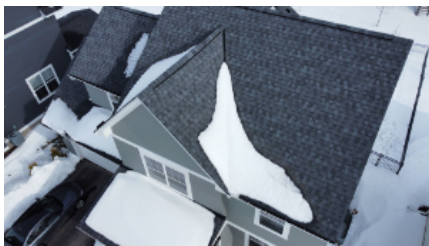
Image 8.1.1

Repair or Replace - As Soon as Possible: Ridge Vent is open air exchange, during heaving winds and snow fall, snow accumulates against ridge vent. During warm weather snow melts and flows into interior attic space. This event is causing a moisture pool around the entryway light fixture. Water then drains down the power cord and chain, resulting in water collecting in light fixture. Moisture in contact with electrical current poses concern of personal injury and inoperable lighting fixture. I recommend replacing ridge vent with different style that has a proper barrier to the exterior elements to avoid moisture intrusion.
